# Appendix 2: Detailed Inventory

# Introduction

This document highlights the field work conducted by the Consultant Team. A full inventory of site features and analysis of opportunities has been provided for each of the 73 Municipally-owned parcels of parks and open space land.

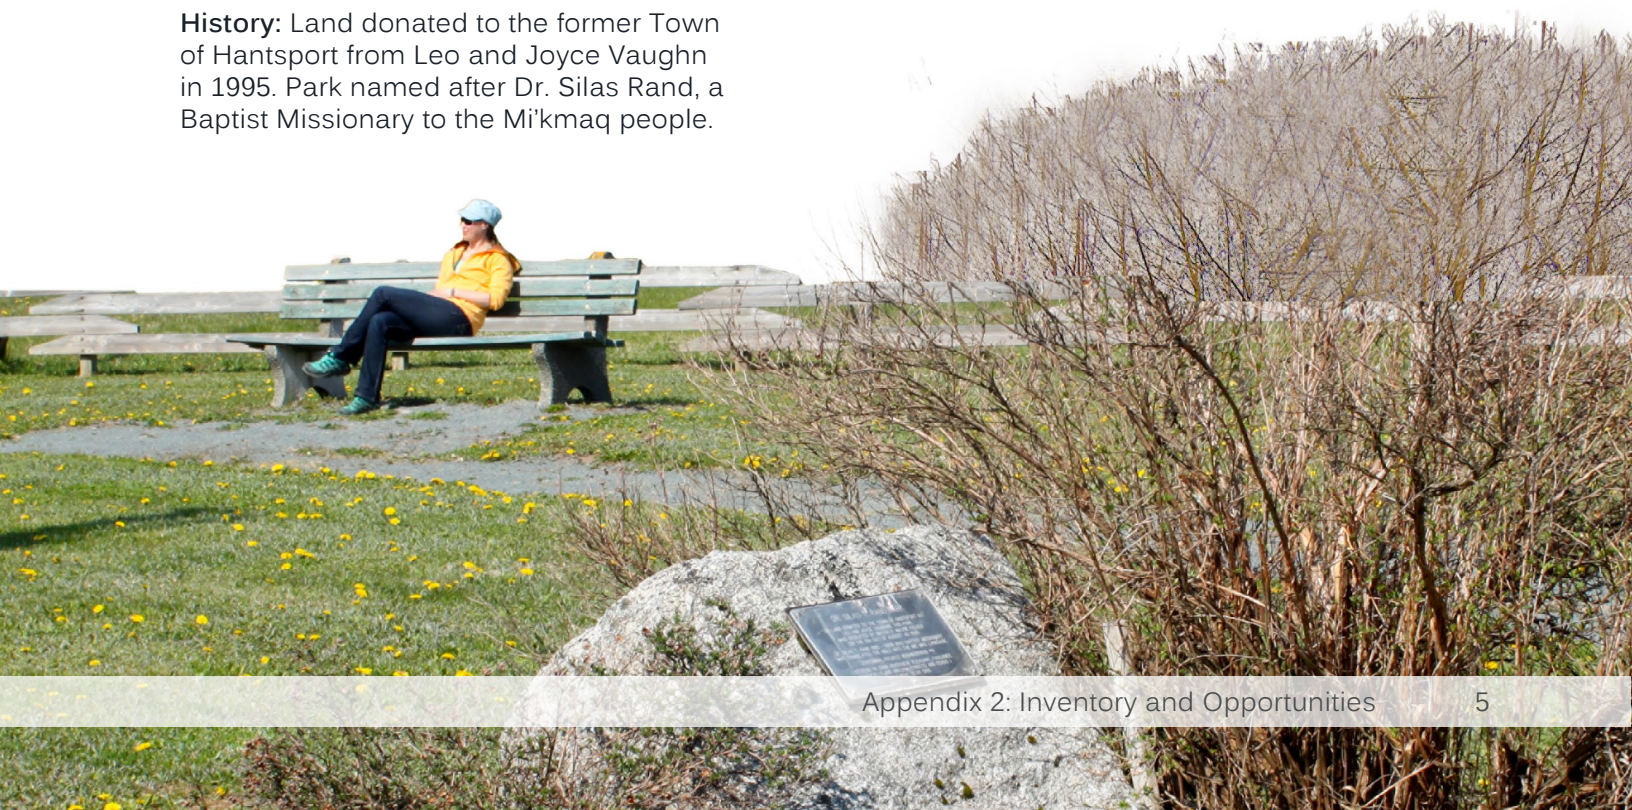
# Dr. Silas Rand Park

- Low wooden fence along eastern perimeter.
- Overgrown corner garden with park history plaque.
- Gravel path filling in with grass.
- No opportunity for shade.

- Park signage.
- More seating options.
- Addition of a shade tree or shade/picnic structure.
- Opportunity area for community gardening groups.

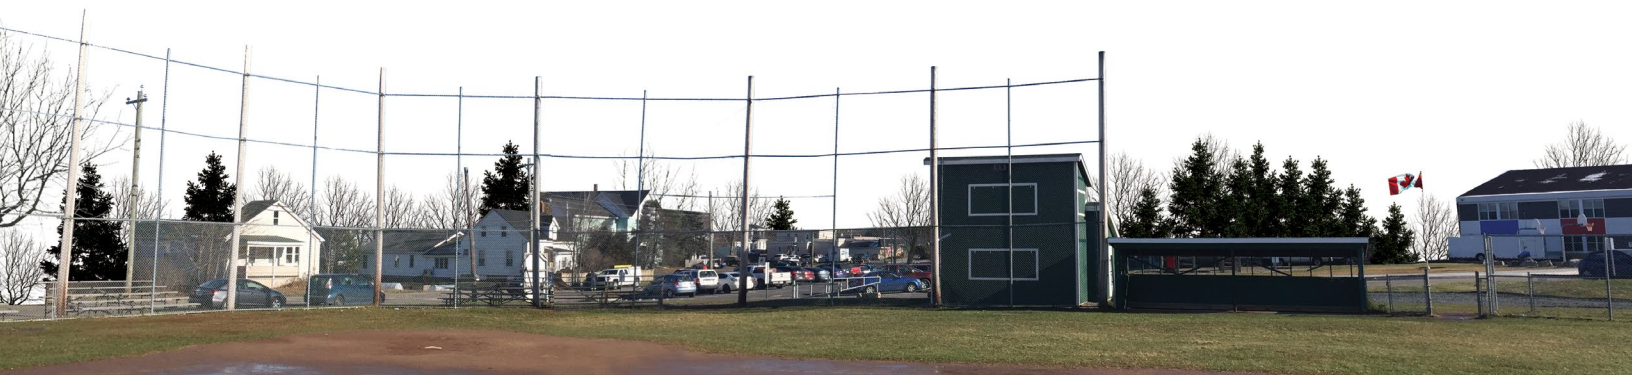
# Shamrock Ball Field

- Well maintained park and structures.
- Standing water in sand and outfield.
- Standing water behind dugouts.
- Two bleachers on site, one outside backstop on sidewalk. Both in good shape.
- Fence on top of dugouts pulling off.
- Some rusting on western bleachers.

- Park signage.
- Addition of garbage receptacles by dugouts.
- Dugout upgrades (e.g. concrete patch work, improve drainage behind dugouts, painting).
- If desired, a treed buffer between residents to the south and west of the field could be planted.
- Investigate community interest and cost of field lighting.

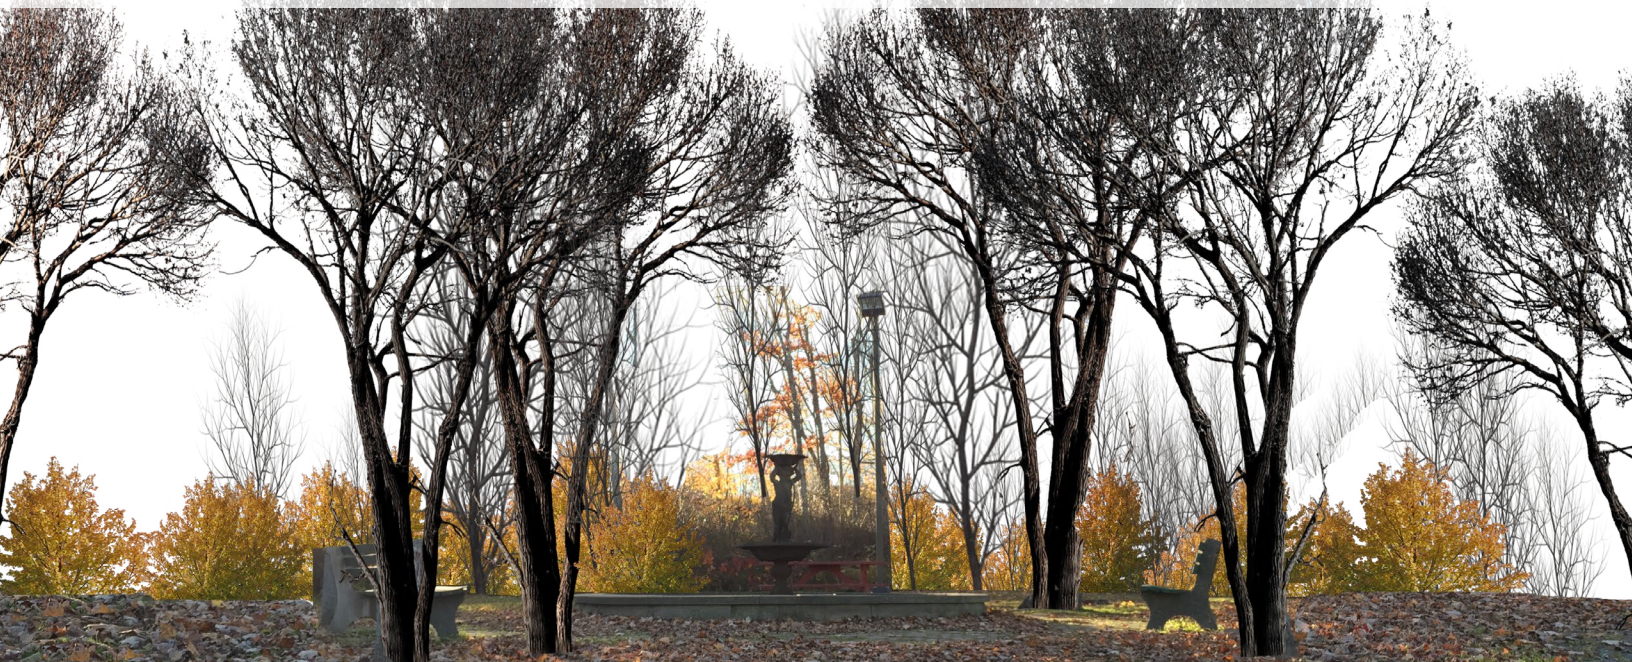
# Chittick Park

- Many trees damaged at bases by mower and trimmer activity.
- Upper park lit by flood lights.
- Fountain in good condition, some stone caps lifting.
- Trees and seating along upper river bed by Evangeline Trail Bridge.
- Well established shade trees.

- Park signage.
- Staff education related to mowing around trees.
- Have an arborist monitor tree condition around fountain.

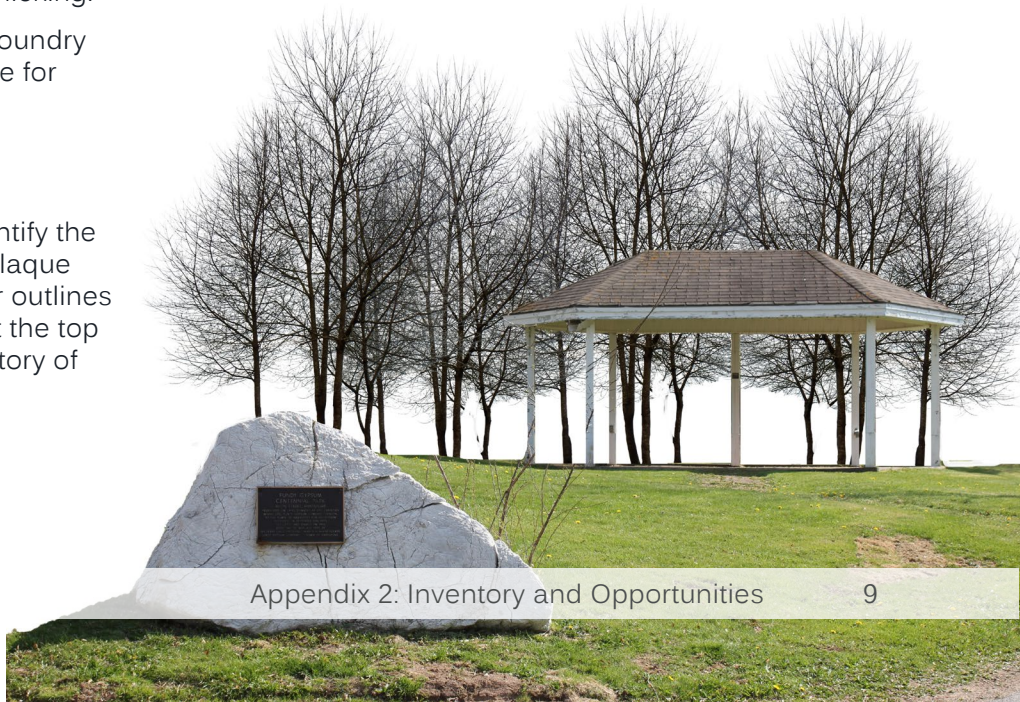
# Fundy Centennial Park

- Washrooms available on site; well maintained and in good shape.
- Park gazebo showing signs of weather damage.
- Wooden staircase to water in good shape.
- Time capsule marked by granite post.
- Brick pad to gazebo (and gazebo base is sunken and filling in with sediment).

- Park signage.
- Need for more garbage receptacles on site.
- Renovation of gazebo needed (e.g. shingles, trim).
- Reset brick pad to gazebo.

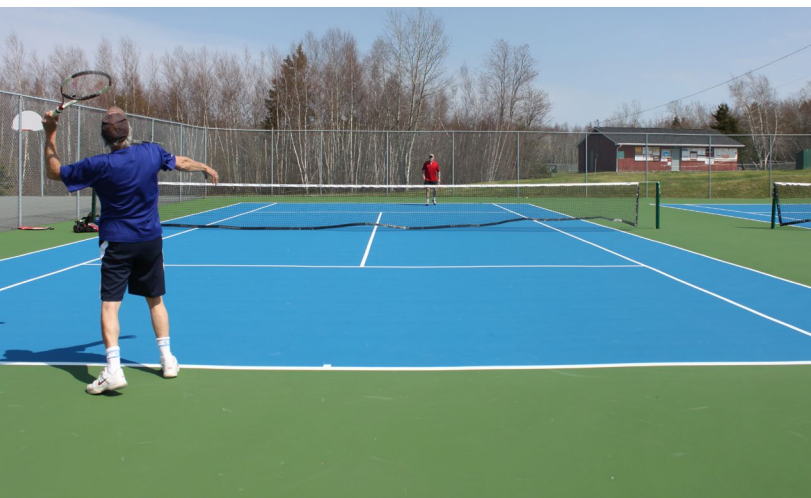
- Recent investment in infrastructure (e.g. tennis court surface, playground).
- Standing water on north and south length of west soccer field.
- North soccer field slow to drain.
- Former softball dugouts in fair shape, roof needs repairs.
- Parking area with standing water.
- Standing water outside play space.
- Former softball field post and chain fence rusting and leaning.
- Retaining wall around former softball field is deteriorating.

- Landscaping upgrades at park entrance.
- Install signage to identify site amenities and trails.
- Correct field drainage for sports fields.
- Paint lines on basketball court.
- Repair and replace damaged boards on benches, picnic tables, bleacher seating.
- Upgrade dugout roofs.
- Redesign the layout of parking area to make more efficient and separate from people spaces.
- Install drainage and new sod around playground space.
- Install new fence along north soccer field perimeter.
- Remove wood retaining wall behind the dugouts at north soccer field perimeter. Replace with drainage swale.

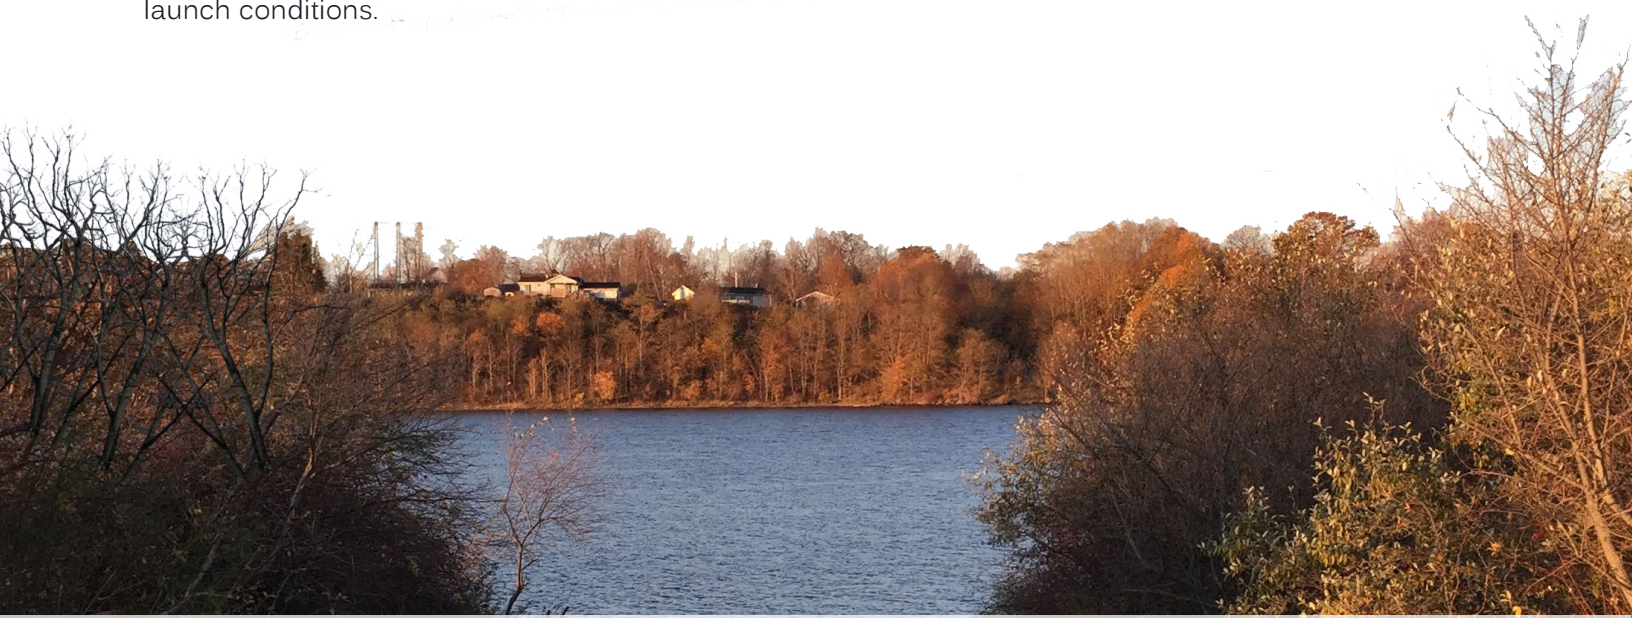
# Falmouth Boat Launch

- Concrete boat launch ramp deteriorating and pieces have fallen away.
- Top of ramp paved with asphalt, in good shape.

- Cut back vegetation from ramp shoulders.
- Remove existing concrete ramp and replace with gravel (short term), concrete (long term).

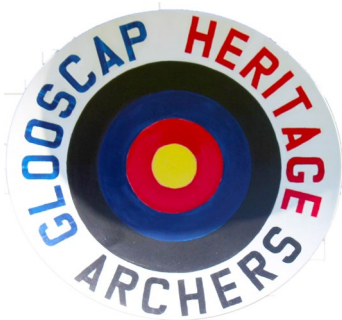
- Entrance to the trail from the second gate is unclear.
- Free standing wall (remaining from landfill) to the north east of the lower field.
- Standing water along trail to the north of the lower field.
- Bleachers at upper field in need of upgrades (e.g. wooden boards).
- Upper parking area needs new base material. Shale is difficult parking surface.
- Area of karst topography found in the north and west areas of the park.
- Fence on the west of the upper field in need of replacement.
- Slumping observed on the west side of the upper field.

- Install entrance and trail signage.
- Design and install interpretive panels to educate the community about former uses, and reclamation of former landfill lands into a recreation facility.
- Expansion of parking area at the second gate and at the upper field.
- Development of a new trail and interpretive area to learn about Karst Topography.
- New fence along the west side of the upper sports field.
- Upgrade sports field (e.g. topdressing, seeding, corrected slumping).
- Potential for additional trails

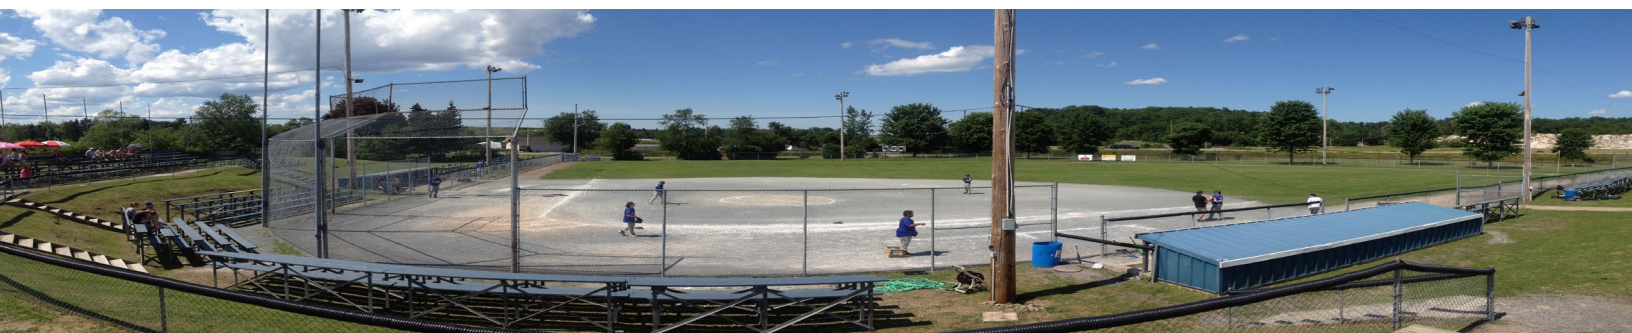
# St. Croix Recreation Site

- Out-buildings are showing signs of weather damage (e.g. water damaged wood, outdated electrical, rotting windows/trim).
- Bleacher footprints made of gypsum (unsuitable structural base).
- Field to east of ballfields is abandoned with old backstop still in place.
- Slope around east ball field bleachers too steep and inaccessible.
- Wiring on east ball field unearthed and is a tripping hazard.
- Wood decking at the top of west ball field is narrow and showing signs of rot.
- Clubhouse ramp on crumbling concrete footings.

- Develop easy access to pond.
- Coordinate signage to indicate park, maintenance, usage, and wayfinding.
- Upgrade wooden out-buildings and clubhouse.
- Replace gypsum bleacher footings with more stable base.
- Install new pathways to improve site accessibility.
- Develop regrading plan for east ball field bleachers are to reduce slope or overcome slope and refine surface materials (e.g. sod instead of large gravel).
- Upgrade decking at top of west ball field observation area.

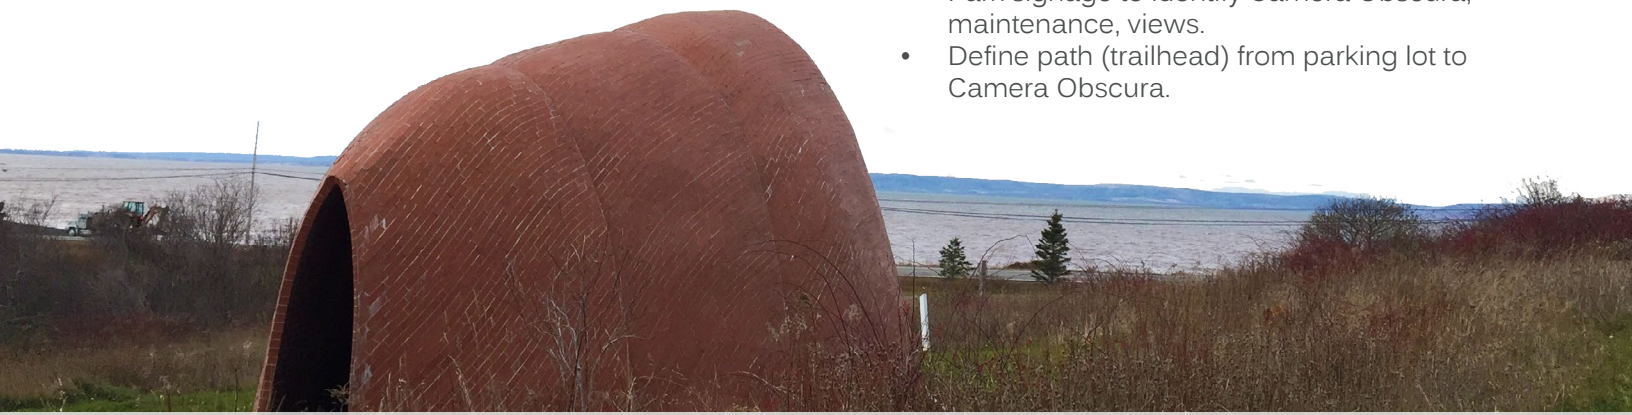
# Cheverie Salt Marsh Restoration Trail

- Marsh signage visible from road, but only indicating marsh. No signage indicating direction to, purpose, or use of Camera Obscura.
- Camera Obscura doors cracked/broken preventing closure.
- Unobstructed views of water and Blomidon.
- Picnic tables and garbage receptacles sited at park entrance.
- Well maintained trail bed, vegetation, trailhead signage, boardwalk.
- Land agreement with adjacent property owner for looping trail from marsh to Camera Obscura.

- Repairs to Camera Obscura internal structure (e.g. door).
- Park signage to identify Camera Obscura, maintenance, views.
- Define path (trailhead) from parking lot to Camera Obscura.

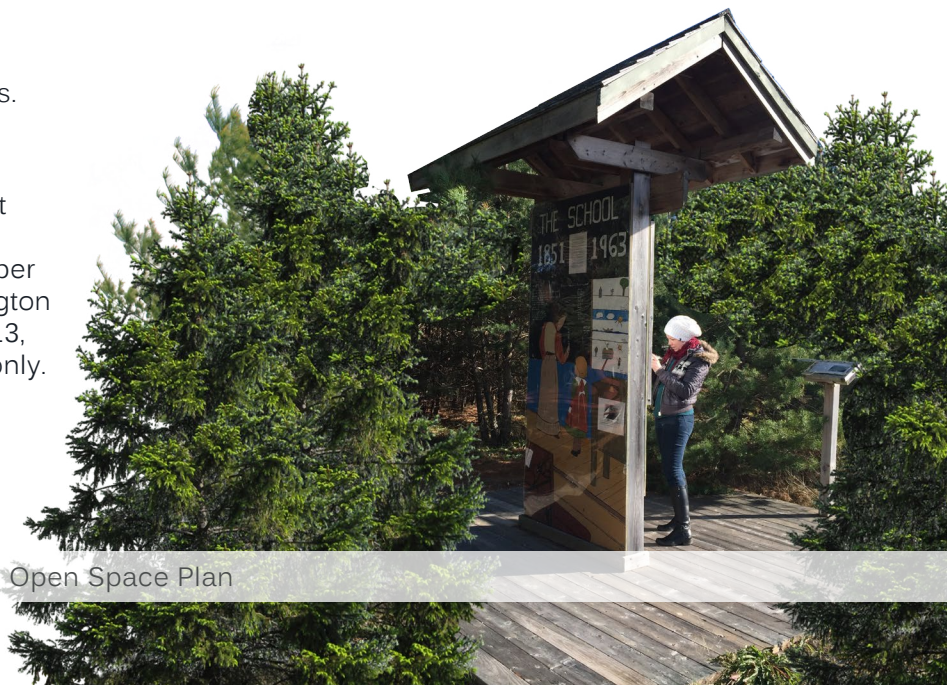
# Upper Burlington Planters Trail

- Community Hall playground and shed on Municipal land.
- Wooden playground not structurally sound. Structure leaning and chains rusting.
- Basketball court (concrete pad) very small with chipping paint.
- Baseball diamond growing in with weeds.
- Interpretive panels in fair shape, some rotting wood, cracked panels, and water damage.
- Trail running from Community Hall along eastern border and along entire southern border.

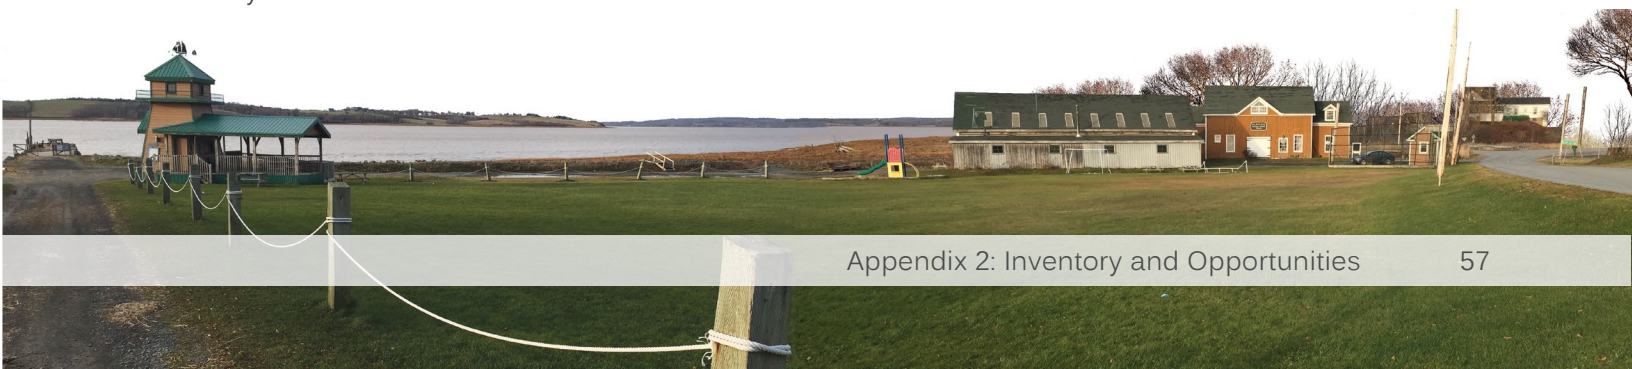
- Outdoor spaces around museum and boat house not well-defined (e.g. parking, gardens, turf).
- Sports field is well maintained. Standing water at field perimeter.
- Playground in good condition.
- Poor drainage, uneven surface, and irregular mixture of materials (e.g. soil, gravel) outside the playground and shipyard shed.
- Tide rising over wharf, boat launch, and driveway causing erosion and structural damage.
- Signage is not coordinated, should be centralized with park use, ownership, and rules identified.

- Site landscape plan to identify optimal pedestrian circulation and landscaping.
- Evaluate the stability and effectiveness of dykes/berms. Further development may be necessary along river to the north and boat launch to the south.
- Engineering assessment of wharf structure.
- New park signage consistent with municipal brand and materials at park entrances.
- The Municipality should consider climate change and work with the MCCAP Committee on projects that relate to the Avondale Wharf and Waterfront.
- Work with the MCCAP Committee to address climate change effects on parcel.
